Manhole Inspection Summary

Manhole # S53A__022MH

Insp Date: **5/6/08 12:11 PM**

Location Address: **3315 pulaski hwy**

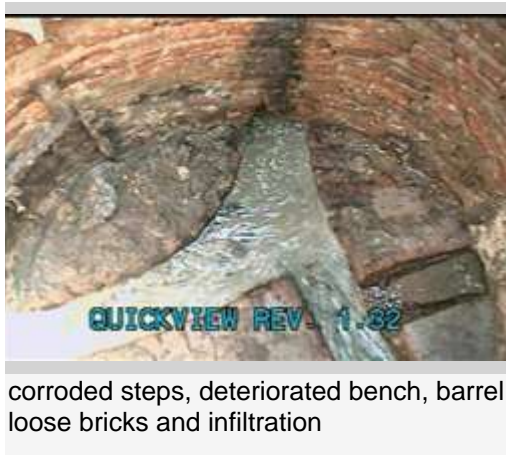
Defect

Condition: ☐ Sound ☐ Cracked ☐ Root Intrusion ☒ **Loose Brick** ☐ Deteriorated

Infiltration: ☐ None ☒ **Joint** ☐ Cracks ☐ Mortar ☐ Roots ☐ Wall

Condition: ☐ Sound ☐ Cracked ☐ Root Intrusion ☒ **Deteriorated** ☐ Leaks ☐ Debris

Count: **3** Missing: **0** ☒ **Corroded**

corroded steps, deteriorated bench, barrel loose bricks and infiltration

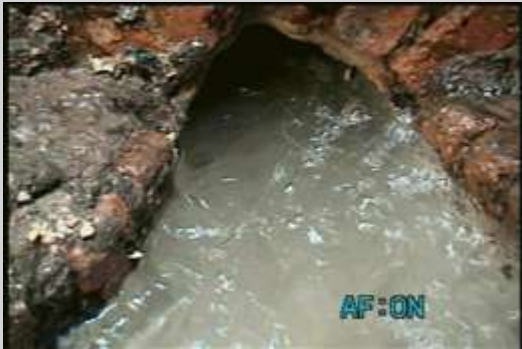
12 O'Clock Outflow

6 in. Circular Gravity Sewer
Pipe Out @ 12 O'Clock

Pipe Material: **Clay** ☐ Pipe Lined

Invert Depth: 7.00 (ft.) Flow Characteristics: **Fast**

Infiltration: **None** Pipe Seal Cond: **Unknown**

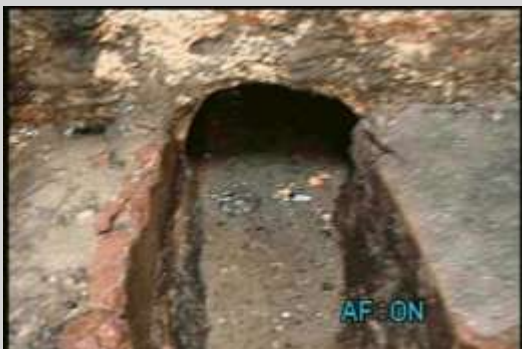
3 O'Clock Inflow

10 in. Circular Gravity Sewer
Pipe In @ 3 O'Clock

Pipe Material: **Clay** ☐ Pipe Lined

Invert Depth: 6.80 (ft.) Flow Characteristics: **None**

Infiltration: **None** Pipe Seal Cond: **Unknown**

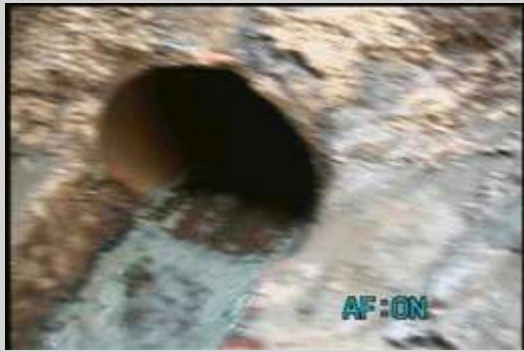
6 O'Clock Inflow

8 in. Circular Gravity Sewer

Pipe In @ 6 O'Clock

Pipe Material: **Clay** ☐ Pipe Lined

Invert Depth: **6.70** (ft.) Flow Characteristics: **Slow**

Infiltration: **None** Pipe Seal Cond: **Unknown**

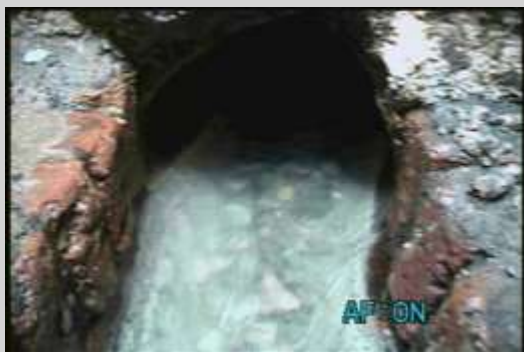
9 O'Clock Inflow

8 in. Circular Gravity Sewer

Pipe In @ 9 O'Clock

Pipe Material: **Clay** ☐ Pipe Lined

Invert Depth: **6.70** (ft.) Flow Characteristics: **Slow**

Infiltration: **None** Pipe Seal Cond: **Unknown**
